Building	Site Name	Site Code	Year / Season
1	Port Louis	PL	2019
Ward number W3	Block number 1	Elevation	Measure, Length
Building/Structure Type Hospital	Building status Disturbed/Restored	Types of analysis Photo	
Visibility Good	Preservation Status Good	Photoplan 3d	
Distinction Parameters Morphology / Shape	Bdg.Type Type G+1	Drone Stratigrafic Analysis	
Neighbourhood Hopital Militaire	Address Quay Street	Texture Photo Sample Construction Materials	
Openings Notes		Stone Agamasse	
Roof Material Agamasse	Roof Type Flat roof	Roof Notes	
Siding Material Stone	Siding Notes Covered with recent plaster/paint		
Dating Elements	The construction started in 1735 it was completed in 1740	Proposed chronology 1735/1740, construction

Block B of the Former Military Hospital in Port Louis, rectangular shape building, 2 stories, main entrance on the south side, other 5 doors (part of them are added in a second phase) 4 windows at the ground floor, 14 windows at 1st floor, flat roof in "agamasse". Coral stones and basalt stones framing doors/windows.

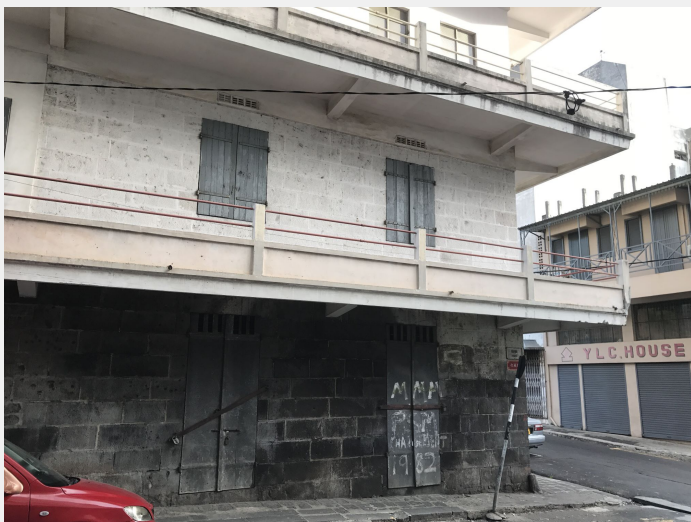
Store or store/office originally type G+1 with a flat roof, now restored with a second store. It has 3 doors on David St. and 2 doors on Sun Yat Sen St.. First floor has 2 windows and 1 door on David street, and 2 windows on Sun Yat. Probably this is due the the insertion of a inner staircase. First floor was recently repainted but the original stone pattern is visible. The aeration system is embedded on the doors on the ground floor, while in the first floor is done with new aereation openings. The original building had a probably wooden terrace, now replaced with a concrete one.

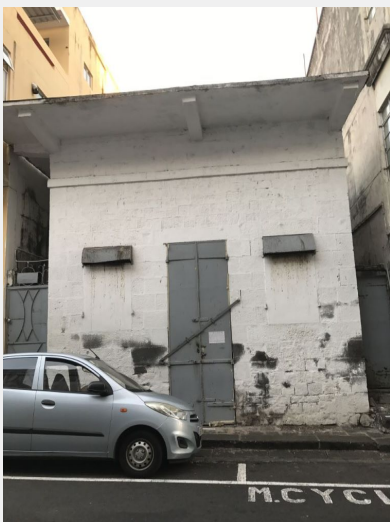
Photo 251-342

Small stone building, 1 floor, with a central door and two windows (now blocked with a wall) original windows had 2 shutters each one.

The construction technique shows use of small roughly squared stones, and large squared stones to frame windows and the door. Door and windows have an architrave on the top. Squared stones used to framing are hammered and smoothed on the sides, with a height of 30 cm.

The same squared stones have been used also for the corners of the building.

The roof level is reached by a stone ramp

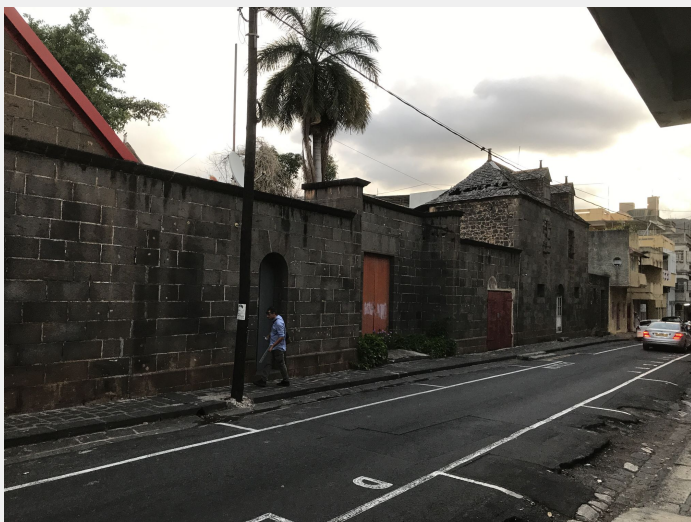
Photo 343-555

Large building with annexes and perimeter wall, with a monumental entrance to the court/garden.

The main building has a facade on large squared stones, an arc-framed door, 2 windows at the 1st floor, and 2 aeration windows at the ground floor. The attic is wooden covered with 2 dormer. Original wooden shutters.

The main entrance (monumental one) is re-entrant and has a large rectangular door with 2 shutters. On the top of the door there is a framed rectangular big stones as an epigraphic space. There were some Chinese idiom...

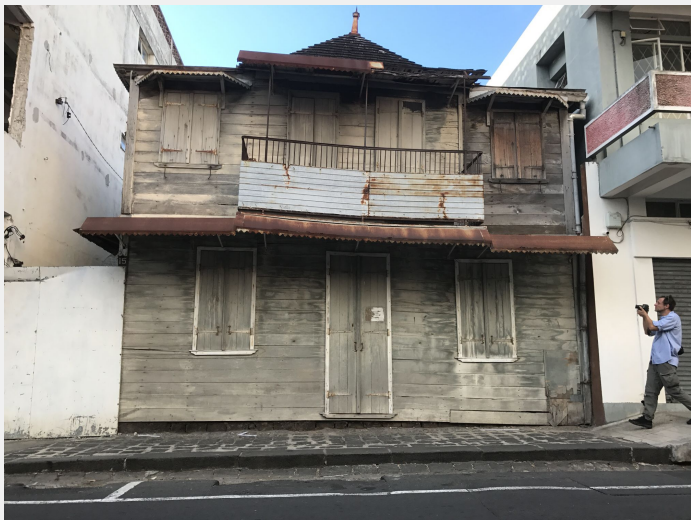
Wooden house. Type G+1+a, it stand over a stone base made by roughly squared stones. At the ground floor as a door and 2 window, with original shaped shutters. Wooden siding, made by 16 horizontal wooden planks. First floor has 13 rows of wooden planks, 3 windows and 1 door. It has a small central terrace/balcony, today with a metal railing. There is a metal original canopy sustained by metal supports connected to the facade. The canopy is decorated with a simple carved motif. Over the 1st. Floor windows there are small canopies decorated with a simple pattern with also a central hole for ventilation.

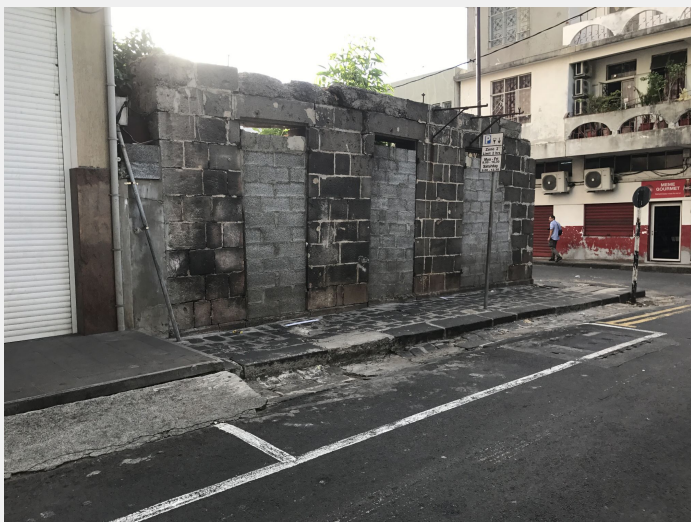
Stone building, 1 floor, with 3 doors on Renganaden Seeneevassen St. and 2 remaining doors in David St. stonework with large mostly flattened and roughly hammered basalt stones. There is a light polished frame on the stones. The bedding and joints are irregulars. Doors are not framed, and they have a carved architrave with the indent for the doors' shutters. It is musing of the roof, abandoned and the doors and missing part have been filled with moderne concrete blocks. There still the metal works for connecting the roof (probably wooden) with the side walls.

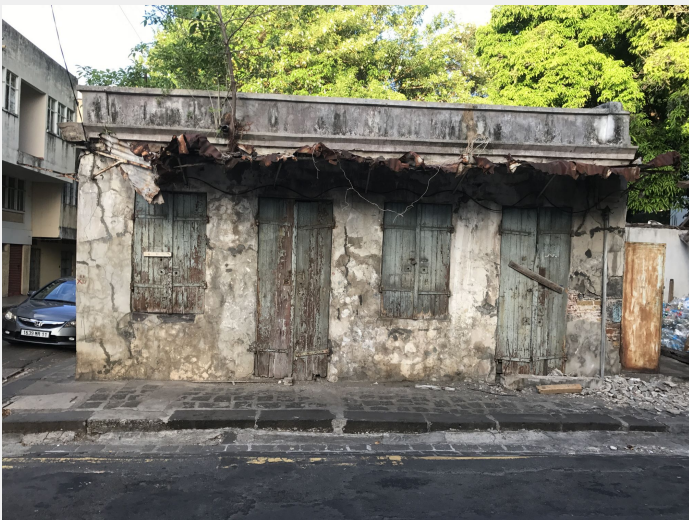
House (?) 1 floor building. It has 2 doors and 2 windows on Renganaden Seeneevassen St. and .1 door and 1 window on David street the floor is flat and probably realized in agamass. There is a cornice on the main building defining the height of the roof, made with brick and plaster mounded in a trapezoidal shape. The siding are plastered (original plaster) coral lime one. The main building is built with reused bricks as Bricked Faced wall (a Sacco). The corners has few reused basalt stones. There is a small canopy with metal supports anchored on the facade and corrugate roof.

The building has a second part on third

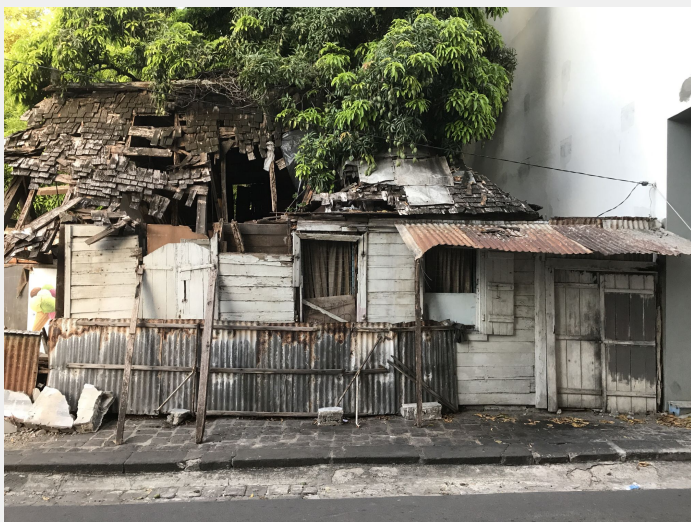
Very damaged wooden house. It stands on base of basalt blocks. On ground floor it has 1 door and 2 windows remaking, plus a wooden door open to unroofed alley. A modern very simple corrugated canopy. Windows are framed with simple rectangular wooden planks. The siding has irregular wooden horizontal planks, some of them are cut in more than 1 piece. The original door was trapezoidal framed. Roof is wooden with wooden shingles. There were 2 metal pinnacles over the roof. The state of the house is very bad, and only the eastern portion is still habited/squattered. Few pieces of corrugated metal have been used to

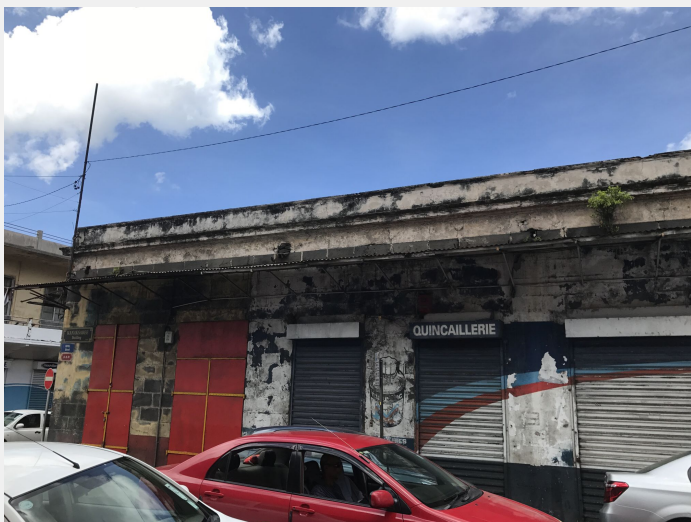
Nb visibile on 3 sides, photo 464
 Large store building with flat roof in the corner between Royal St. and Sun Yat Sen St.. The store is made with stone carved blocks and agamasse roof with metal shutters. The building presents the original shutters in part of the store while the openings configuration in Royal St. has been partially adapted to obtain 4 new doors with metal shutters. On the better preserved side in Sun Yat Sen St. there are. The walls are covered with light yellow and white poorly preserved plaster. On the side of the Sun Yat Sen St. are also visible part of the original stone side wall made with smaller and

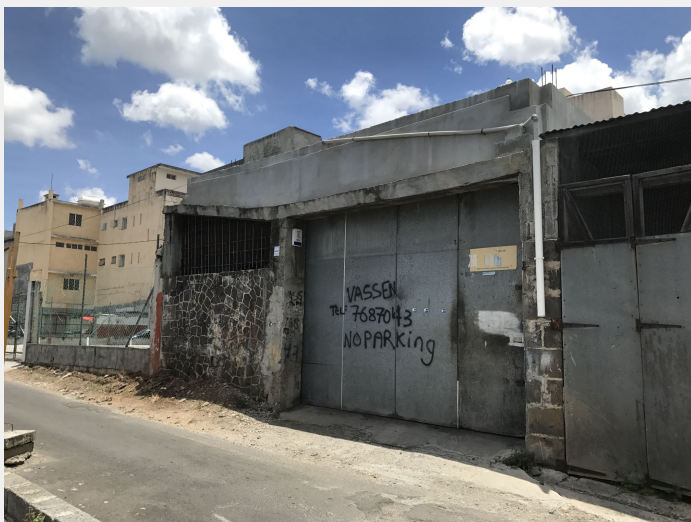
Ph code, DSC0465
 Part of a preexisting building absorbed in a new construction. Only a part of the original stone wall is still preserved.

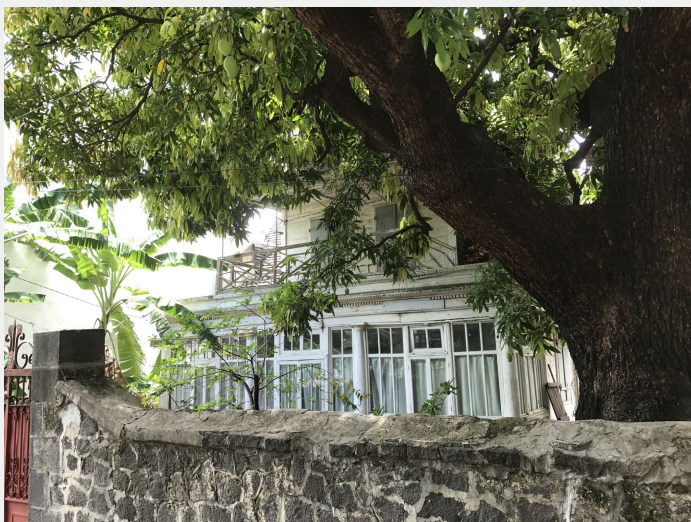
Photo 472-76

Wooden colonial house painted in white with ground floor and attic(?). The identification of the architectural feature is difficult due to the very poor visibility: a great tree in the garden is covering part of the roof and higher walls of the house and also the property is enclosed in high walls made of carved stone blocks. Nevertheless, the house presents some monumental characteristics and a very fine and decorated enclosed front element with columns and decorated frame. On the attic, a balcony with two doors is surrounded by a hip roof with dormers. The house has also a considerable

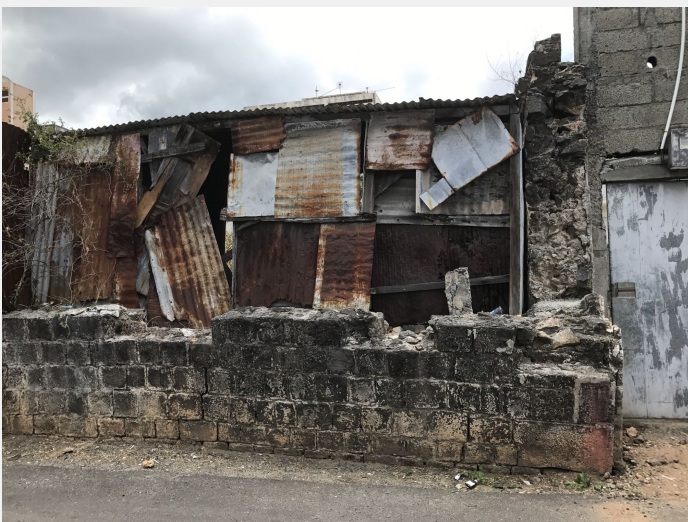
Photo 477
Remains of stone building (store/warehouse type) adapted with corrugated metal to form a smaller space. Of the original building remains only the lower part of the facade and a part of the side wall, also in stone.

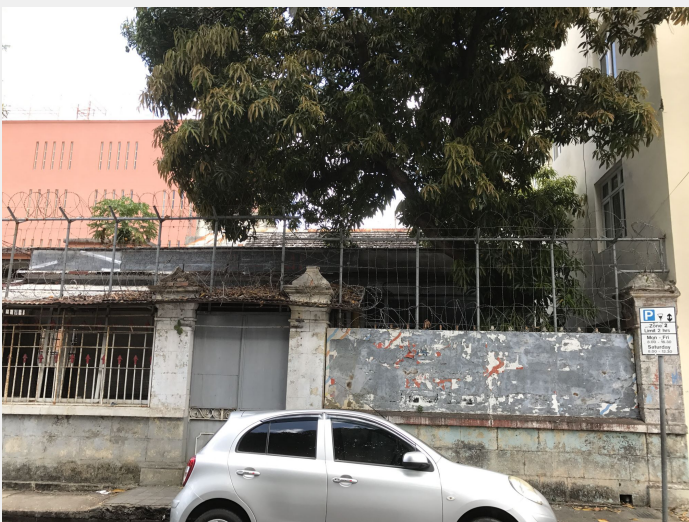
Photo 478

Wooden house, probably restored with metal elements, with very poor visibility. Throuout the vegetation and the high fenceare visible only a few traits as the vooden hip foor, some metal frames with decorations and a decorated vertical element.

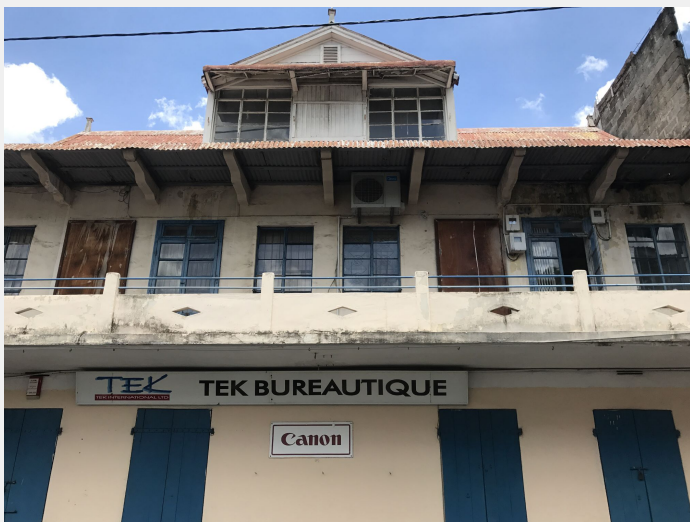
Photo 484-85

Store/warehouse sufficiently well preserved with ground floor, first floor and attic. Construction material of the ground floor is difficult to inspect due to the presence of a thick plaster. The first floor seems made of concrete based materials but is articulated in shape and morphology like other stone observed building. It is possible that the present configuration of the building is due to a restoration that preserved the original morphology. On this floor, many doors and windows with glass and wood shutters open on a balcony with decorated railings. At the highest level, the attic stands under a

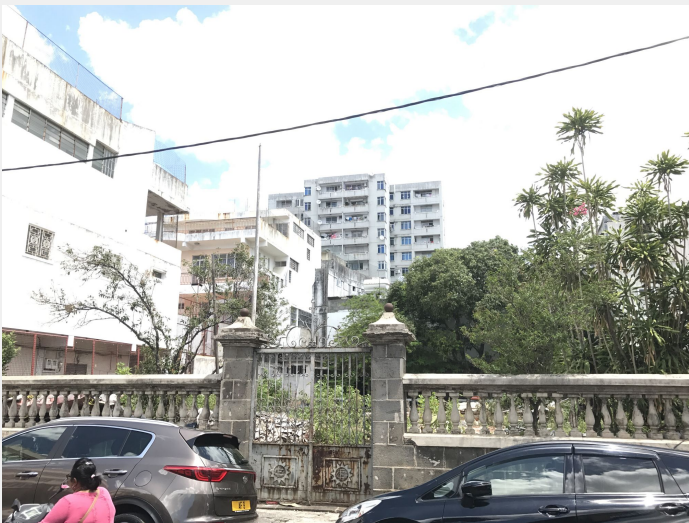
Ruins of a large house with a metal decorated fine gate and a concrete and stone elegant fence. The architectural details of the house are uncertain because of the ruinous state of the building. KEEP IT?

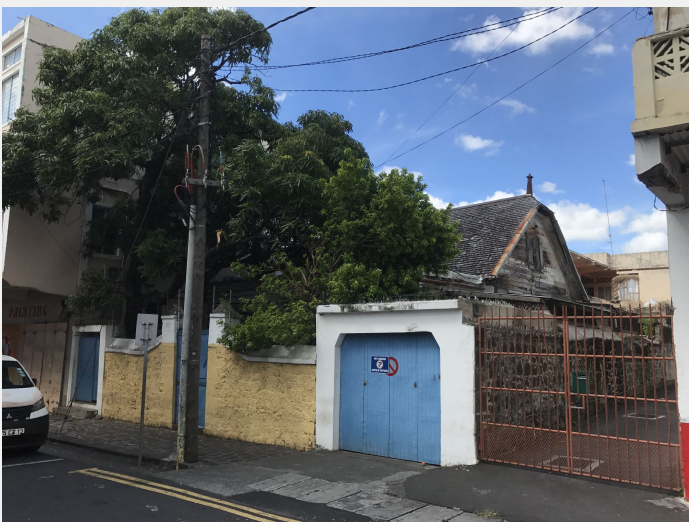
Photo 510-11

Large wooden house with GF, attic and a garden. The flourishing vegetation and the high stone fence with metal gates prevent the full visibility of the architectural features. The house seems entirely in wood, with roof covered in rectangular small shingle, a part for some metal sheet on the edges of the roof and the traditional metal pinnacles. Although the house is still perfectly standing, the preservation status seems precarious, and some collapses and broken planks are visible on the front.

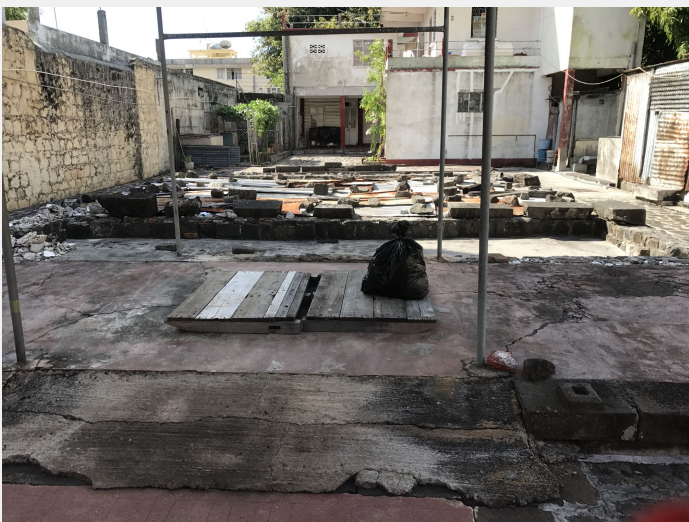
Foundation levels Photo 519
Remainings of a recently dismantled house with stone base and wood. TO KEEP?

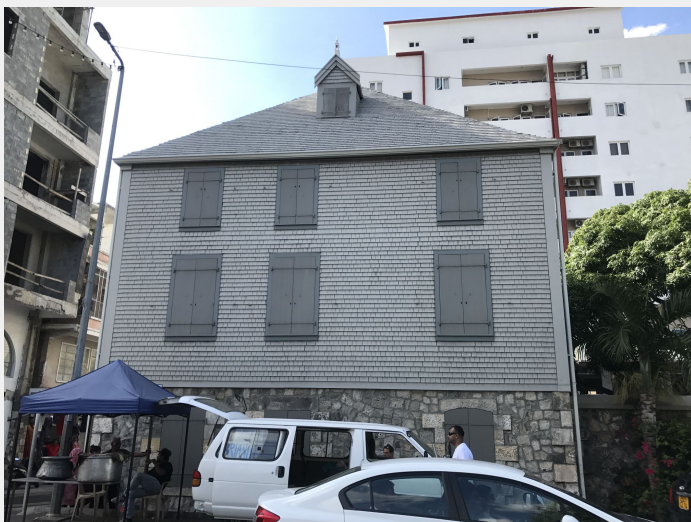
Photo 530
First and second floors covered by wooden tiles

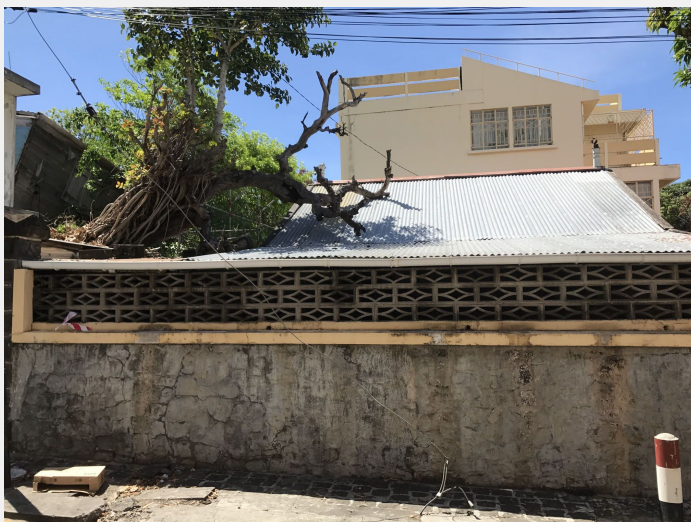
Photo 189
Oriented differently, north-east side

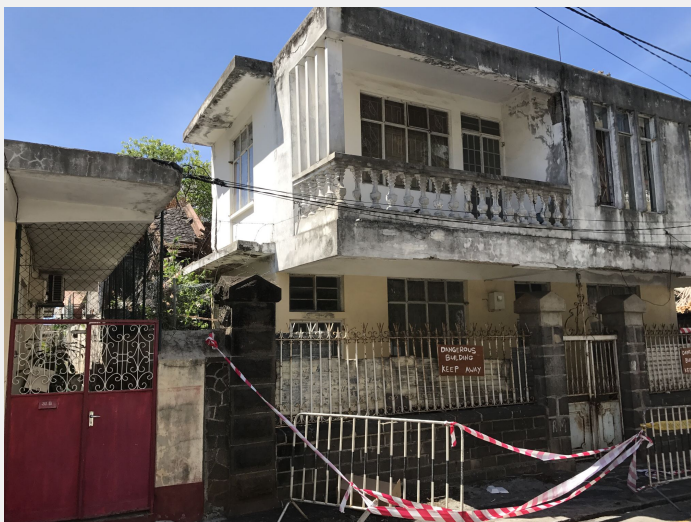
Photo 192
Ancient house on the back side of a modern concrete one. In ruins

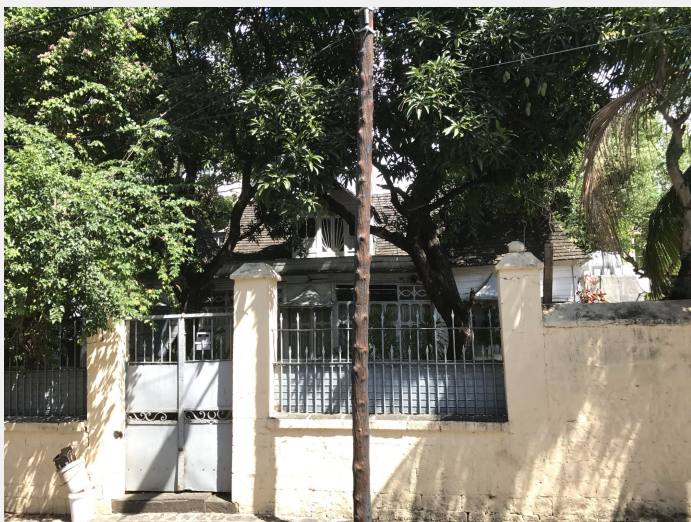
Photo 194-96
Remarkable shape and technique but many tree inside and upfront

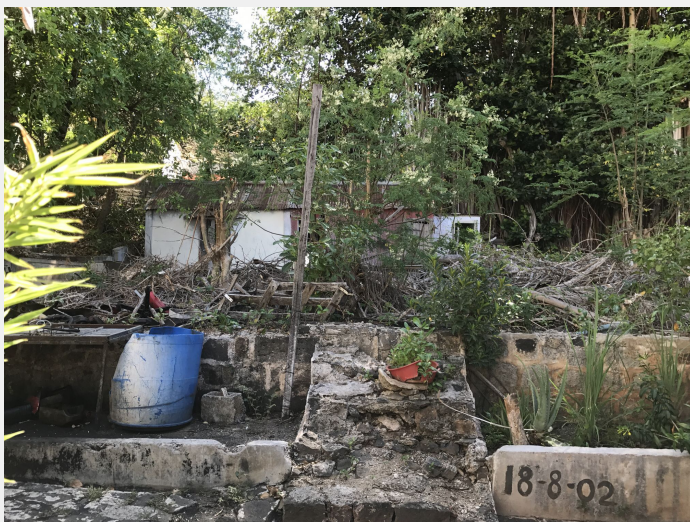
Photo 197
Former house reduced and partially ruined. Today only a small portion of the original building remains preserved.

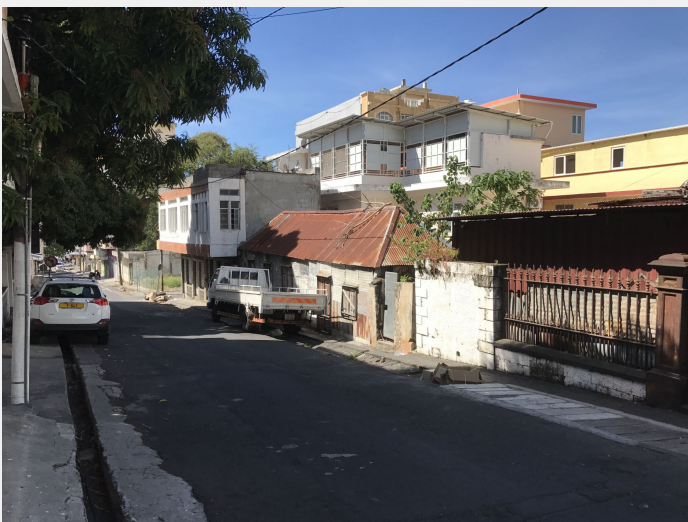
Photo
Probably rebuilt building with previous shape of a gable roofed store

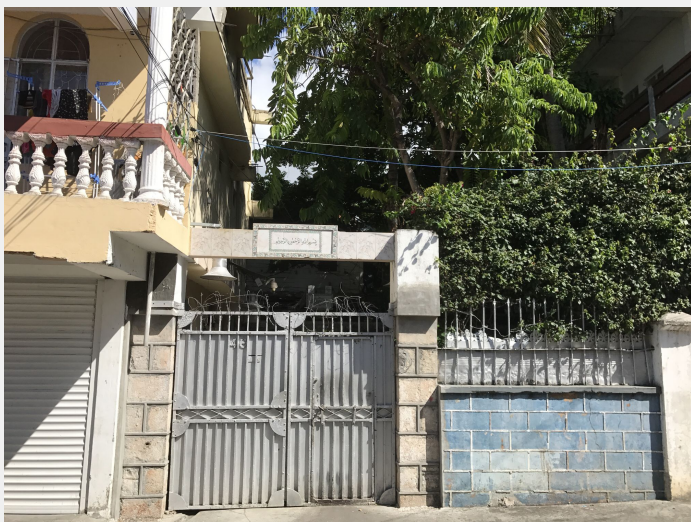
Photo 207-208
 Wooden house restored and modified but still visible in the inner space of the block.
 Probably Muslim inhabitants, Arabic inscriptions on the front and inside.

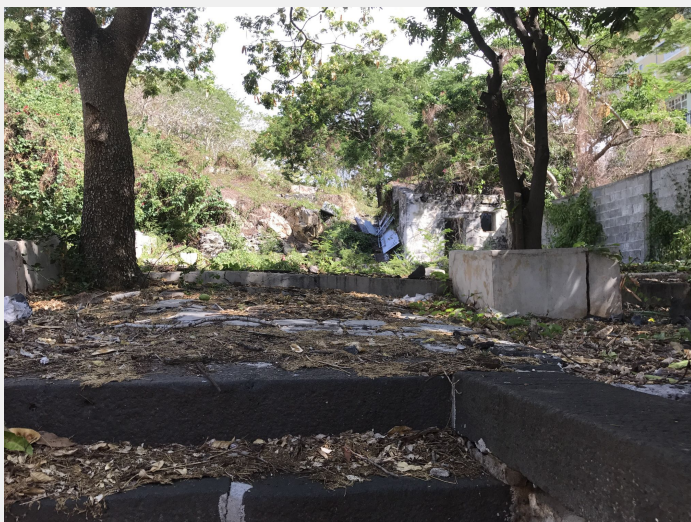
Photo 209-211
Surviving annex of a wider construction no more visible.

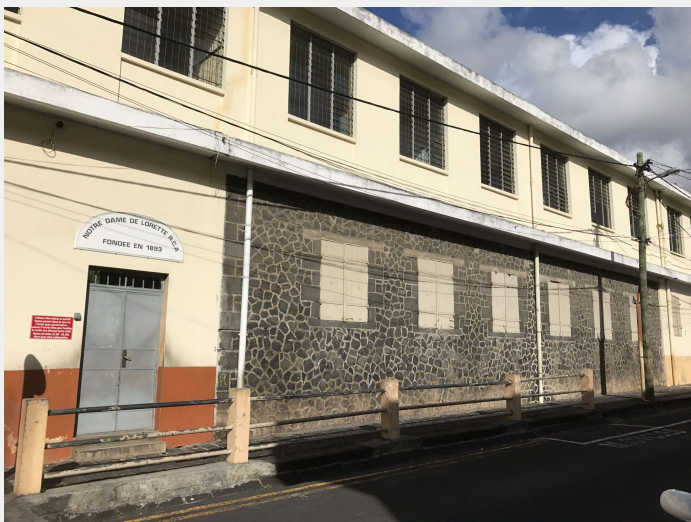
Foundation dated back to 1893.
 Photo 217-219
 All the north and east part of the property is closed by a wall made by stones.

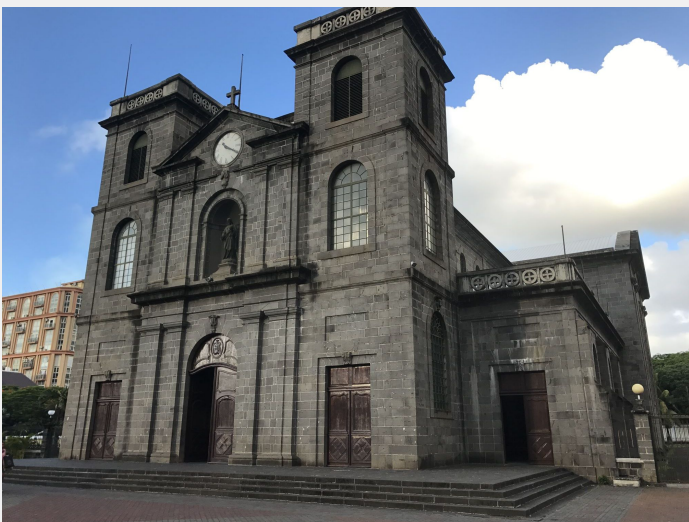
Photo 243-248

One of the best architectural accomplishments of the 20th century Mauritius. Built during the governorship of Magon beetwen 1752-1756. It was rebuild a large part of the cathedral, including the foundations and it is was finally consecrated by Monseigneur Leon 13 years later.

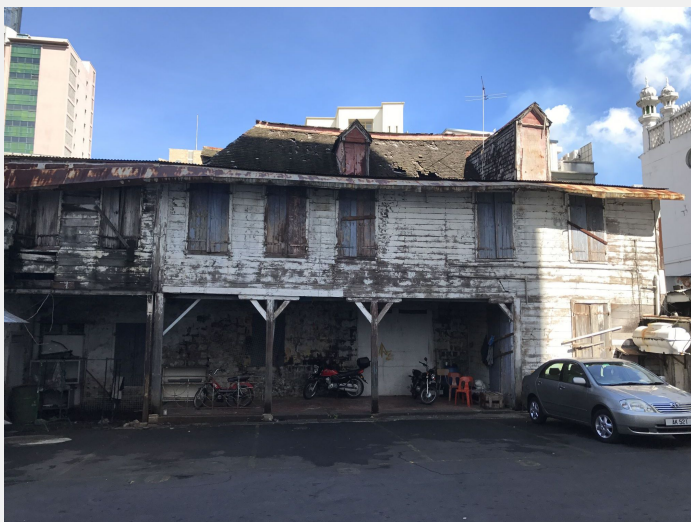
Photo 654-652

The building é visibile sul retro accedendo da Barboun St. tramite un cancello trovato aperto. Il retro é composto interamente in legno (piano terra e primo piano) mentre la facciata principale su SSR conserva solo il primo piano in legno mentre il piano terra é oggi occupato da alcune attività commerciali e con muro intonacato, pertanto non é possibile interpretarne la tecnica costruttiva. Il primo piano è interamente un dormer roof con pareti esterne in legno rustic vee.
