Building	Site Name	Site Code	Year / Season
1	Port Louis	PL	2019
Ward number W3	Block number 1	Elevation	Measure, Length
Building/Structure Type Hospital	Building status Disturbed/Restored	Types of analysis Photo	
Visibility Good	Preservation Status Good	Photoplan 3d	
Distinction Parameters Morphology / Shape	Bdg.Type Type G+1	Drone Stratigrafic Analysis	
Neighbourhood Hopital Militaire	Address Quay Street	Texture Photo Sample Construction Materials	
Openings Notes		Stone Agamasse	
Roof Material Agamasse	Roof Type Flat roof	Roof Notes	
Siding Material Stone	Siding Notes Covered with recent plaster/paint		
Dating Elements	The construction started in 1735 it was completed in 1740	Proposed chronology 1735/1740, construction

Block B of the Former Military Hospital in Port Louis, rectangular shape building, 2 stories, main entrance on the south side, other 5 doors (part of them are added in a second phase) 4 windows at the ground floor, 14 windows at 1st floor, flat roof in "agamasse". Coral stones and basalt stones framing doors/windows.

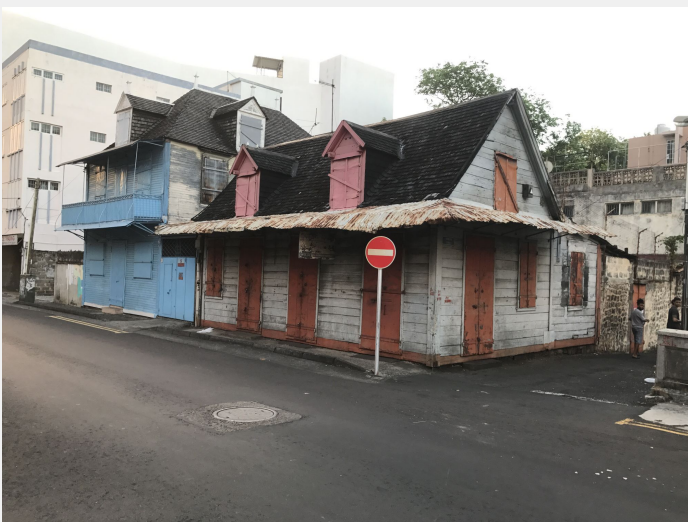
Store, maybe used also as house, it has a Sign" Kiaw Won 91. Store. General retailer and Motorcycle spare parts". Ground floor and attic with two dormer. On the main facade it has 3 doors and 1 window, on the north side on Barbeau St. it has 1 door and 2 window, plus a window on the attic space. It stands over a basalt base, siding are with wooden planks, regular size and horizontal. Openings are simple framed. Metal shutters. It is painted on gray with red doors and windows. The bottom plank is also red. There is a simple corrugated canopy with supports holding on the facade. Roof and dormers are wooden with wooden

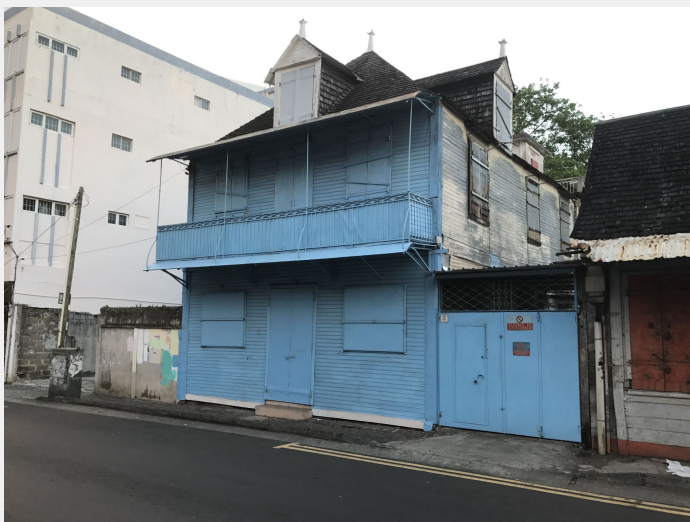
Photos 466-469

Store(gf?)-house with ground floor, first floor and attic with a wooden structure and metal openings. The wooden roof has one dormer for each side of the building. The facade has 2 window And a door. The shape of the lower windows is wider and longer than the upper windows.

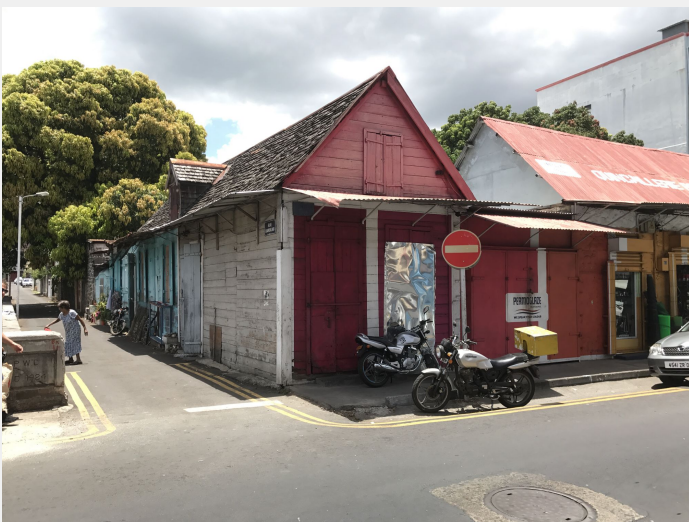
Photo 470,71

Wooden and stone composite residential building in Royal St at the intersection with Rue Barbeau, with ground floor and attic. The complex is composed by two different part, a wooden one in Royal St. and a stone one in Rue Barbeau. The originally stone building (store/warehouse?) was soon readapted to residential use with the modification of openings and a new type of roof. To stone building was also added a wooden part on Royal St. most likely for commercial use. The side on the street has only doors on the ground floor and instead the residential side has also windows above

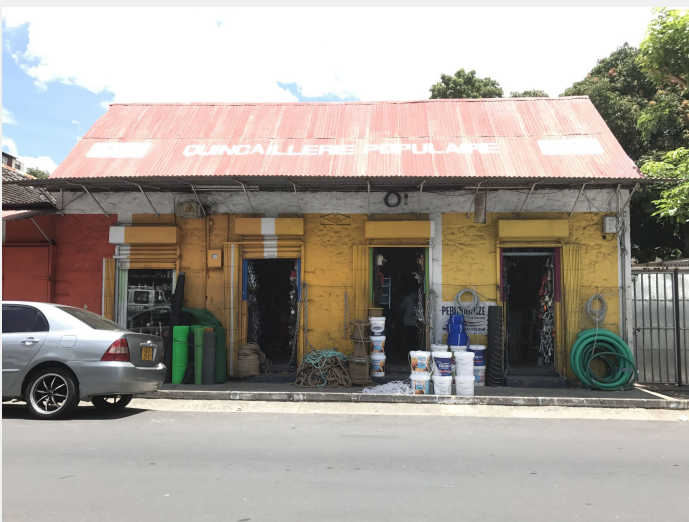
Photo 479

Store/Warehouse in stone with 4 openings on the main facade, recently painted in yellow, white and red. The gable roof with a short canopy, in corrugated iron was probably wooden in the original design. Thank to his position on one of the main street of the neighbourhood, the building has maintained his commercial use. A commemorative plaque indicates "N. V. 1923", might determine the date of construction or the latest substantial restoration.

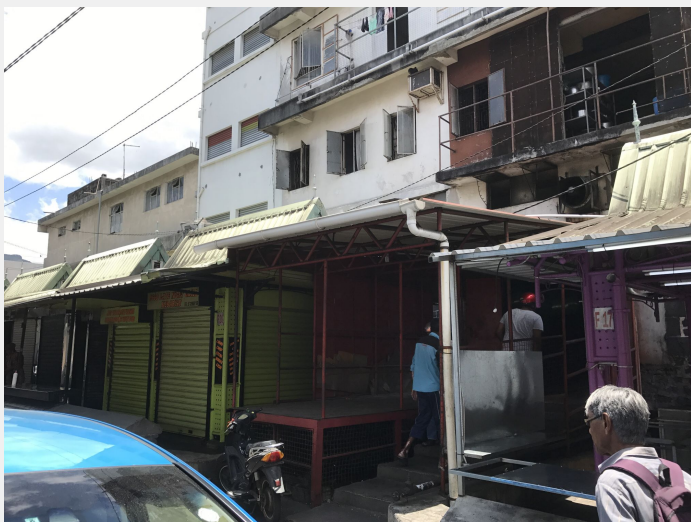
Photo 480

This building is visible only for a small portion due to the recent/modern superfections and variations. Of a precedent building in well carved and refined squared stones remains only a small portion of the ground floor. The wall is made of medium stones with abundant white mortar, probably recently restored. On the right side still visible of the wall, there are bigger stones in the texture, disposed as a frame for a preexisting opening subsequently enlarged to reach the actual dimensions. Aside for these small portions of walls, very little is visible of the original configuration. Hence, it is impossible to

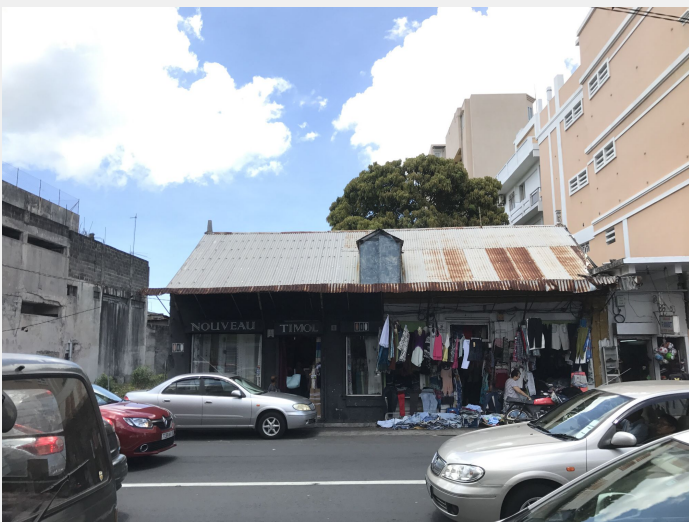
Photo 481-483

Store/Warehouse made originally in stone with restored corrugate iron roof. Covered on the front by the metal structure of the market, with short metal canopy, difficult visibility.

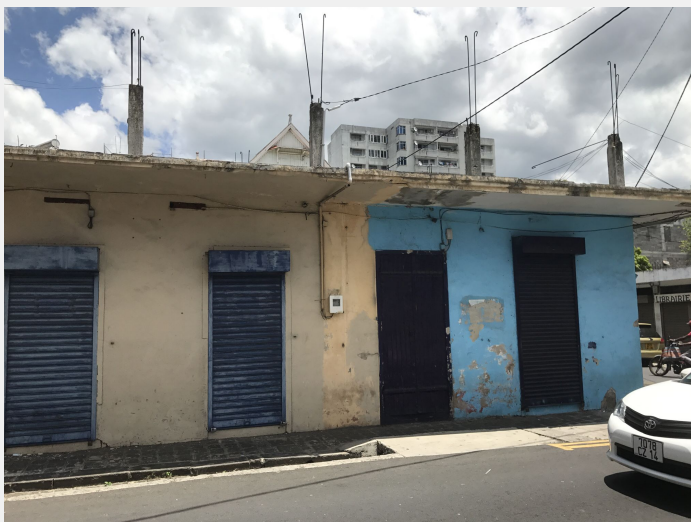
Photo 486-487

Store building in sone with GF and many openings on the main sides, the openings on La Paix St. have a small step right in front of them. The building has been modified in the upper part. The regular stone texture is visible only in some sparse spots, covered by the white, blue and yellow thick painting. All the shutters are new, apart maybe for the red one and the blue one in Remi Olier St.

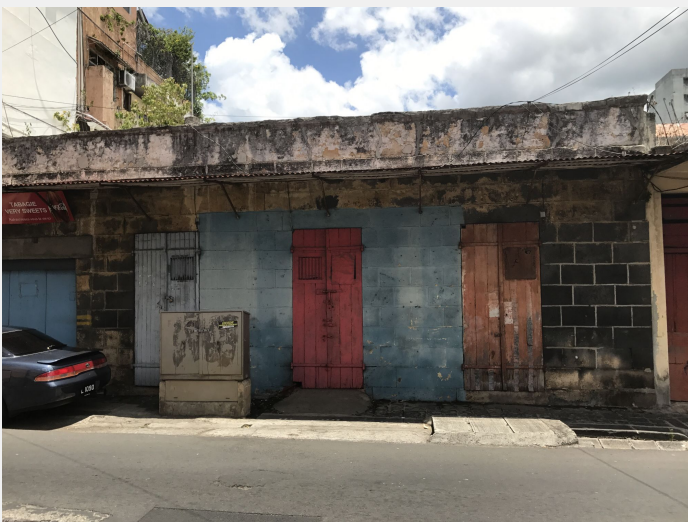
Photo 488-89

Store with only GF with stone walls made with rectangular and very regular elements. The roof, in agamasse, with straight design. The building has been readapted/restored with the addition of a small canopy in corrugate iron and also the wide opening on the right is likely to be opened recently. The store is partially covered with blue and yellow painting but the laying is visible underneath. Three of the four openings on the main facade seems to be the original ones.

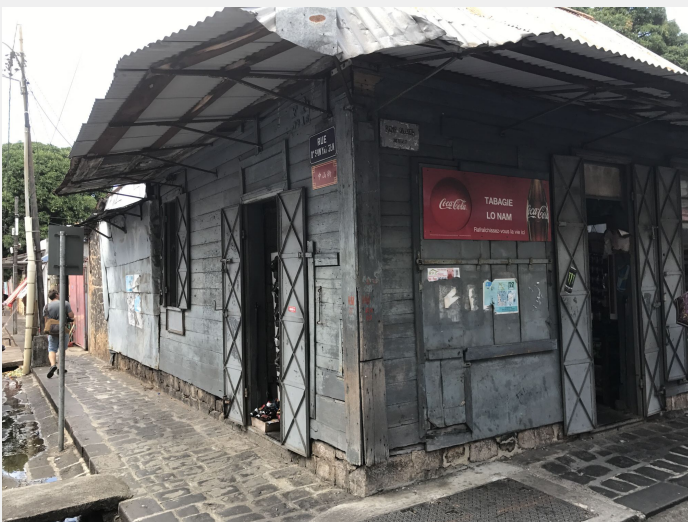
Photo 493

Wooden shop in Remi Ollier St..The building, on the GF only, has a completely wooden structure built upon a stone base visible at the ground level. The rest of walls, painted in gray, are made of wood plank, horizontally disposed. The roof, recently restored is incorrugate iron and include a short canopy on the street sides. The shutters are in metal and wood, the metal ones seem new. On Sun Yat Sen St. side of the building an annex with flat roof is made with corrugated iron incorporating a stone wall portion still visible going further (building n. 29)

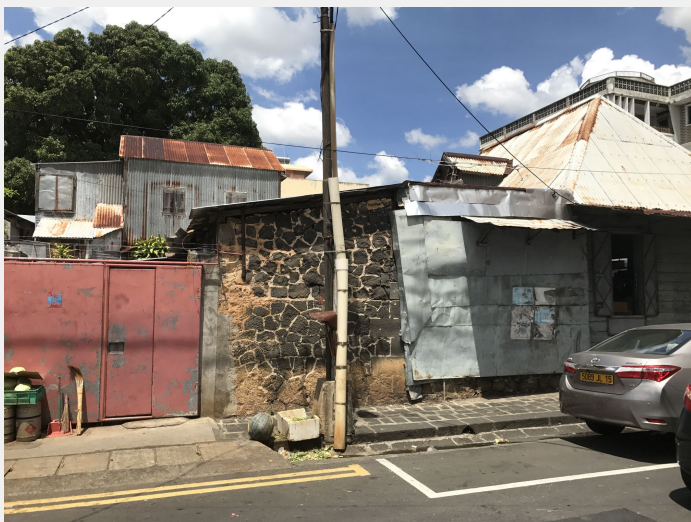
Photo 495

Wall of a preexisting building partially enclosed now in a new construction (building 28). This portion of the original wall is preserved up to the roof and is made of roughly squared basaltic stones with an almost regular setting joined with abundant white lime mortar, probably refilled. On the right side, are visible some bigger blocks part of a frame for an opening, probably a door. The wall is now effectively part of the building n. 28, with corrugate iron flat roof. The wall presents sparse traces of yellow paint.

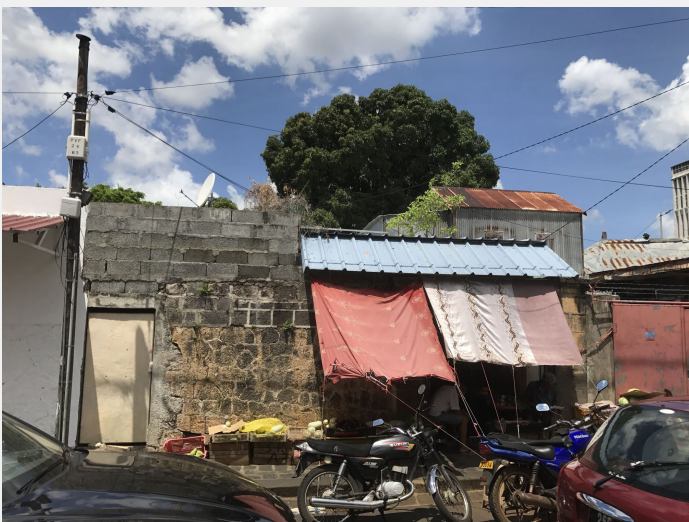
Photo 497

Stone portion of a preexisting building enclosed in a modern store with structural addition in concrete and corrugate iron roof. Poor visibility of the remaining portion of the wall. The structure is partially covered with yellow painting.

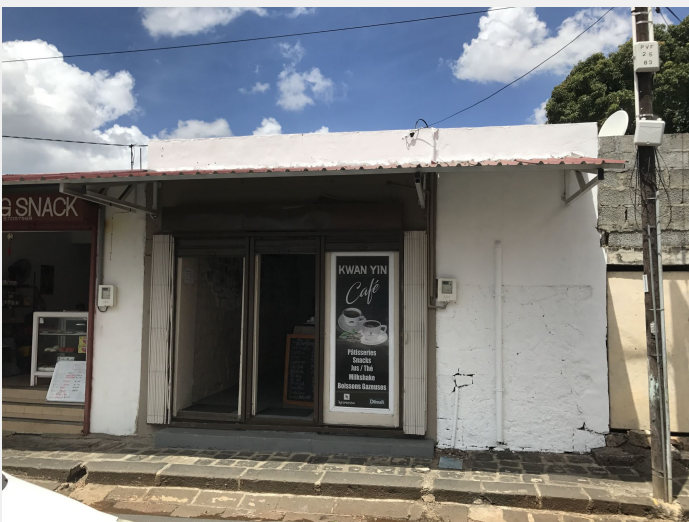
Photo 498
Modern store on Sun Yat Sen St. with restore portion of original stone walls inside, heavily restored with new painted plaster and refilled beds and joints. The original use of the building, is difficult to determine.

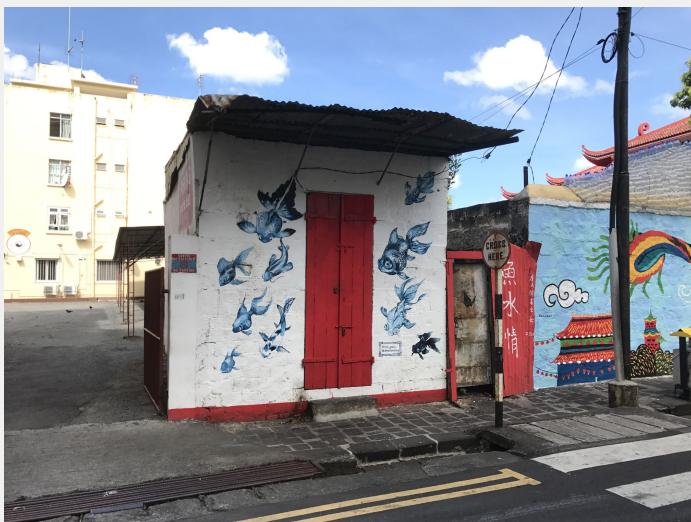
Photo 503-505

Remaining part of a stone store overlooking the street, with only one wooden door left. The building, with corrugate iron flat roof and a small canopy on the front, was recently repainted and decorated witha colourfull murales. The building han been reshaped with concrete adjuncts on the side. In front of the only opening left, there is a small step on the ground.

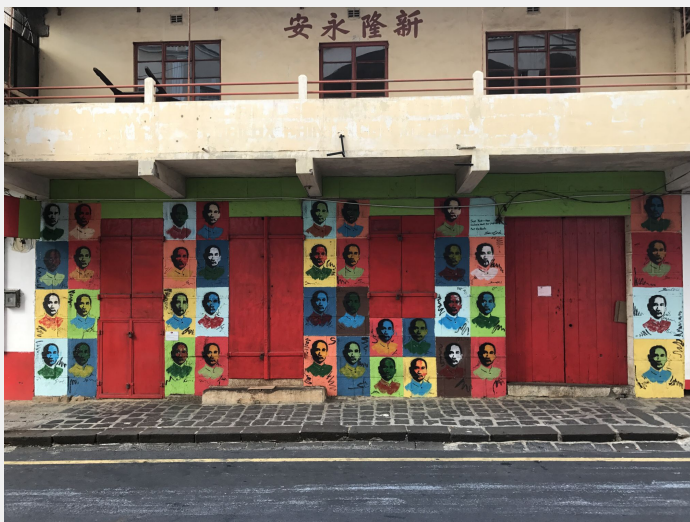
Photo 506-9
Preexistent stone store incorporated in a new building. Colourfull murales on front. Three of the original shutters are preserved and also the stone front wall.

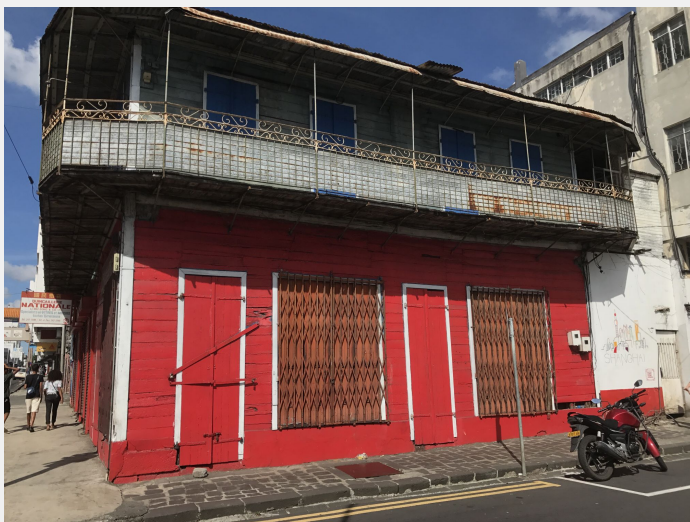
Photo 512-515

Store/office in wooden sidings, stone base and mixed shutters, original (metal) and new ones. The roof is in wood rectangular shingle with two dormer on the front and just one on the other side; also metal pinnacles on the edges. The building has a metal balcony with wooden floor, with decorated railings. The stone base is composed by one course of heavy big blocks barely visible because of the covering red plaster. The store has been recently repainted in vivid red color on the ground floor, instead the first one is not painted. Doors and windows are painted in shades of red light blue in the first

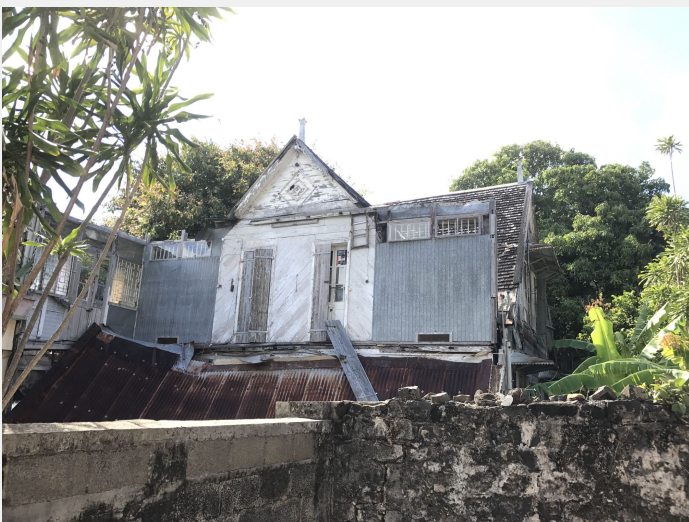
Inner block photo 516-18

Wooden house reshaped and enclosed in a new building with metal and concrete additions. The original part is now in a precarious state of conservation and is visible in the inner part of the block, when the front of the building is completely modern/reshaped. Part of the original attic is visible, made in wooden planks and shingle roof with a decorated triangular section on the edge of the roof instead of a dormer. This appendix is decorated with geometric motifs a wooden frame with ovals. The edges of the roof are decorated with metal pinnacles. On the side, one can see the original wooden shutters.

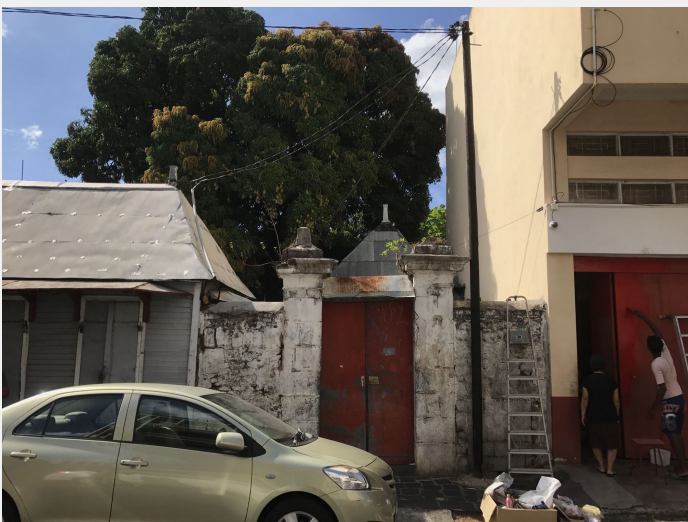
Inner block photo 521

Wooden house with corrugate iron roof and metal pinnacle on top. Restore/reshaped; the roof originally was made of wooden shingle, some fo wichstill preserved on the edge. openings and windows not visible. In front of the house, a stone and metal gate prevents an open view of the building.

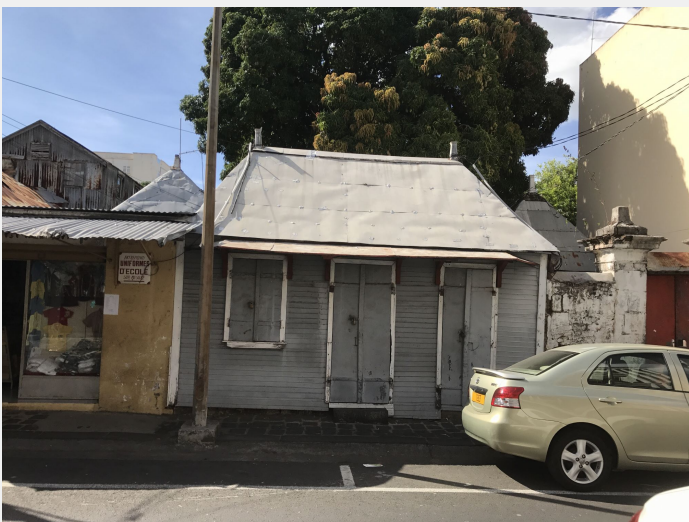
Photo 522

Wooden Store; overlooks the street. The structure is entirely sided by iron sheets with wooden frames for the openings. The building has 2 doors and a window on front, the central door with a small step in front. A thick layer of light grey painting covers up the main facade. The roof has two metal pinnacles on the edge and the openings are underlined with white simple wooden frames.

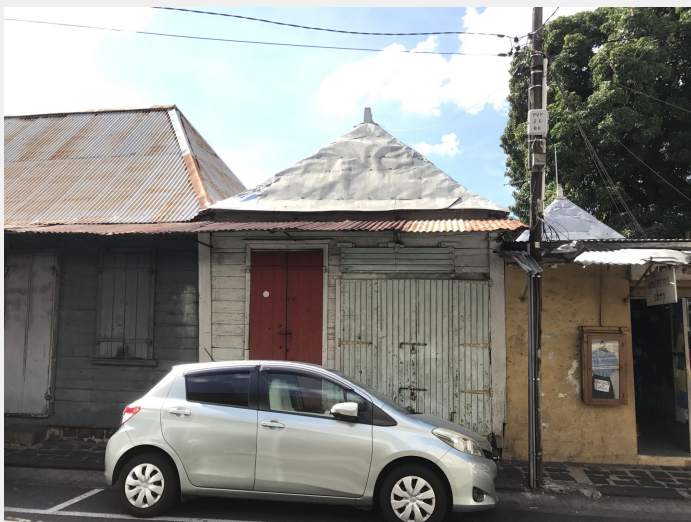
Photo 525

Wooden store subsequently enlarged on the back with appendix in corrugate iron. The front side on the street seems original, apart from the restored roof in metal sheets. The wooden plaks of the facade are painted in white while the original door wooden door has been recently repainted in red. A small canopy in corrugate iron extends toward the street.

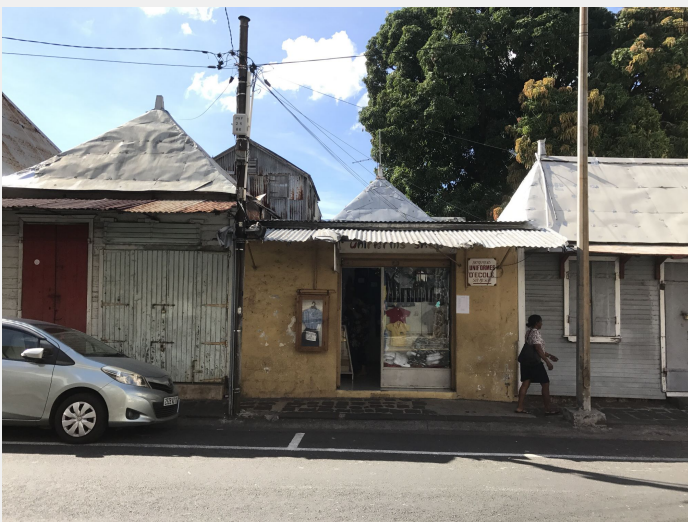
Front side photo 523
 Stone store with GF and corrugate iron roof, probably restored. The thick yellow plaster on the front of the building covers the stone blocks. On the front, with one large opening, a small canopy overlooks the sidewalk.

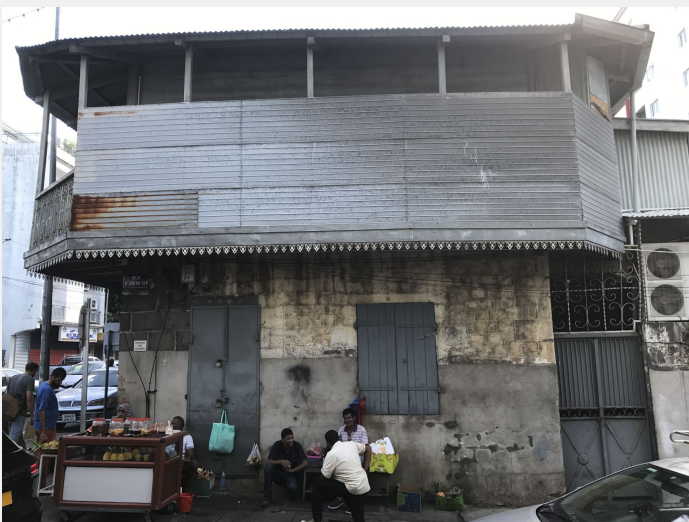
Photo 527-29

Store/office building with GF+1 floors. Stone ground floor in coursed masonry with big regularly carved blocks. 8 openings with decorated frames and metal shutters (wavy upper element in door and windows) and also geometric decorations on stone blocks above the openings. Wooden first floor with sidings in wooden planks. 12 openings, alternate window-door sequence (6d + 6w). Wooden shutters with simple squared frames. Corrugate iron simple roof with tight canopy sustained with wooden vertical elements, covering a balcony with decorated railing with elaborate motifs.

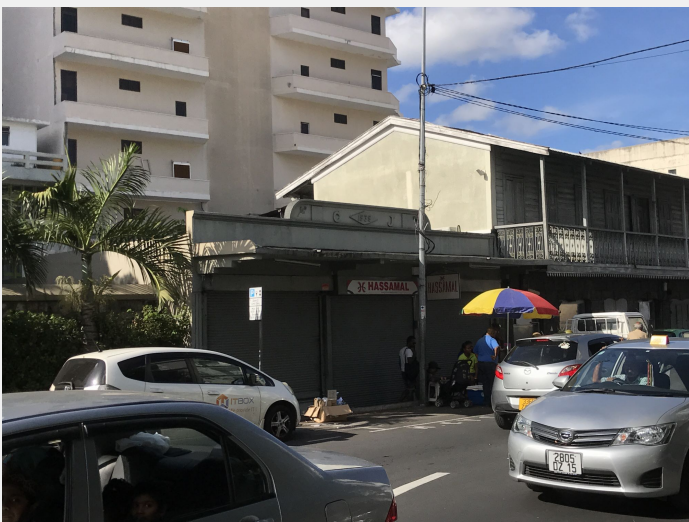
Photo 531
Store, only Ground floor. Concrete building with 1 opening and two shop windows. Flat concrete roof with upper decorative plaque indicating the date of construction "C; 1939; J". Short concrete canopy on the front.

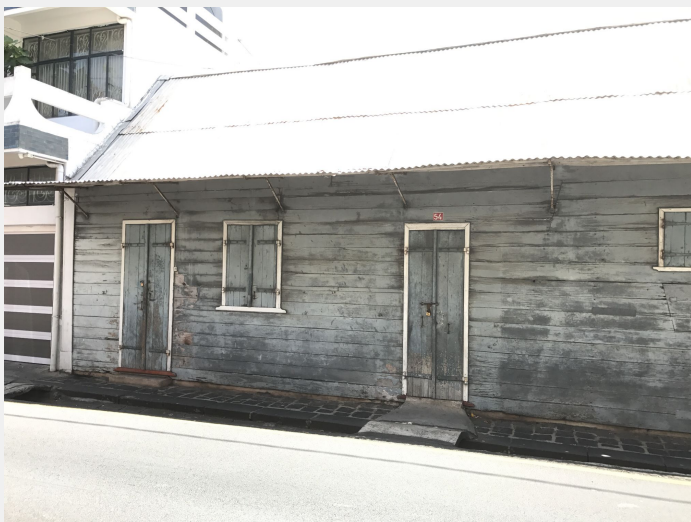
Photo 803-10

Store type building with wooden sidings, stone base and iron corrugated roof. Ground floor and attic. The wooden elements of the siding are well disposed although some cut and conjunction are visible. The ground floor is divided in two different color, maybe dividing two properties, but the building was built altogether and has the same characteristics (??). One part in painted in lighter blue. The openings have a simple frame painted in white. The roof, in corrugated iron is gable type with a dormer on the frontal side. On the lateral side of the building the window in the first floor has a

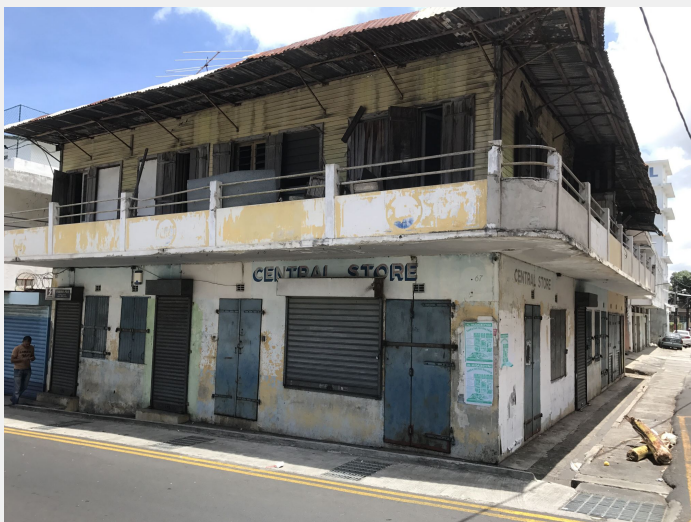
Photo 38-40
Gf stone covered in plaster, 1 floor wood, roof overlapped iron plates, balcony concrete

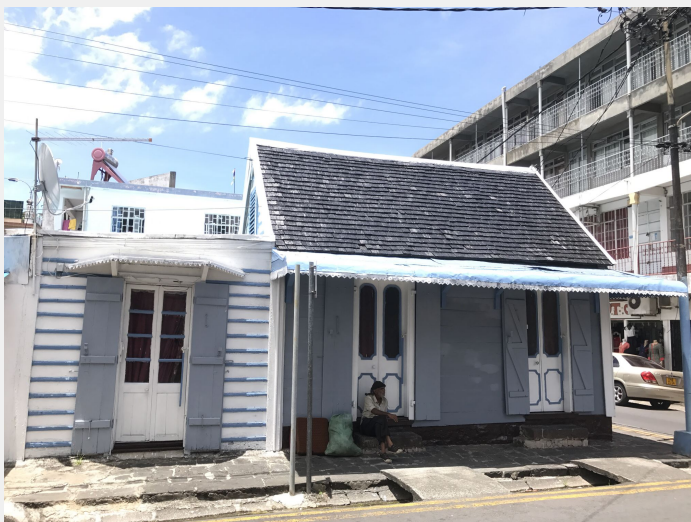
Photo 41-44
 Date on the front 1865
 Composite building
 Interesting technique and decorative parts

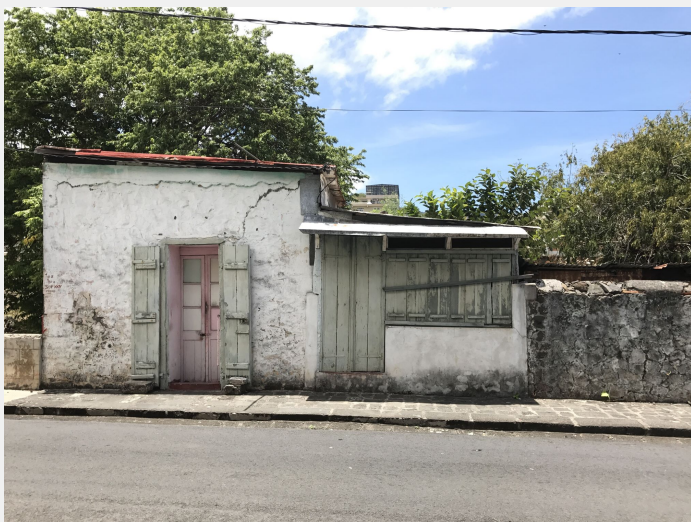
Photo 46-49
small building on the street with annexes (house??). Stone, concrete white plaster. Iron corrugated roof overlapped.
Angular stone bigger than other, chaotically posed and smaller ones for the facade. A part for the main building, the annexes are partially wooden. The wooden annex could be the external bathroom. The structure continues until the river level, below the street level.
Main facade painted in white plaster, annexes in concrete white plaster.
On the back, multiple restoration and modifications. Side windows were probably

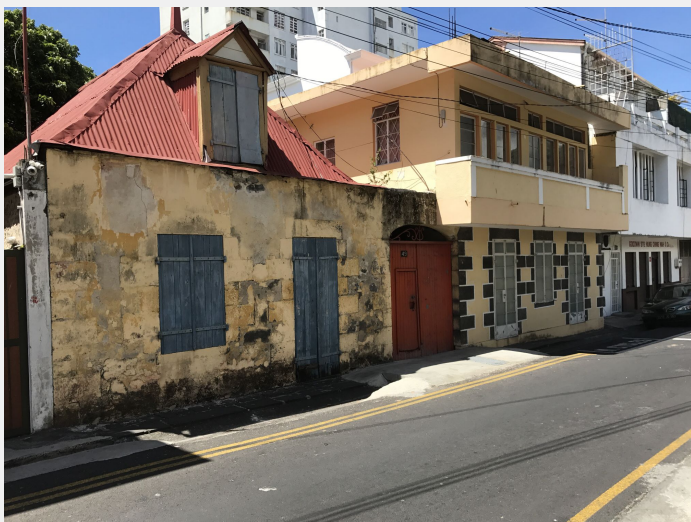
Photo 187
This building and the subsequent are part of a same design and technique but separated by a roofed alley

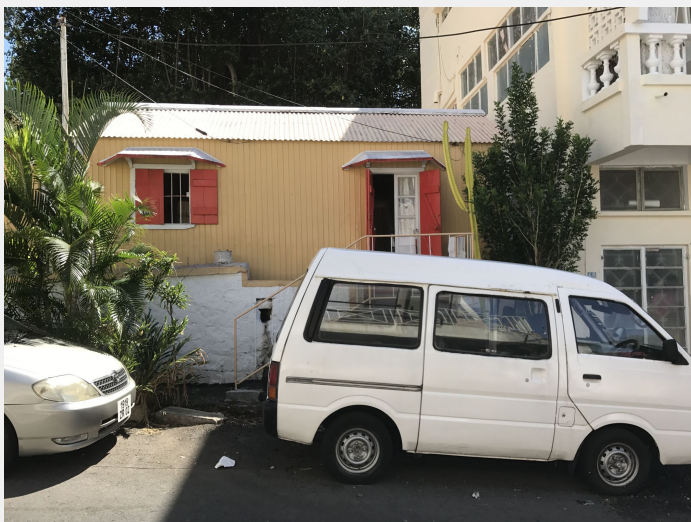
Photo 198
Wood sidings
Iron corrugated roof

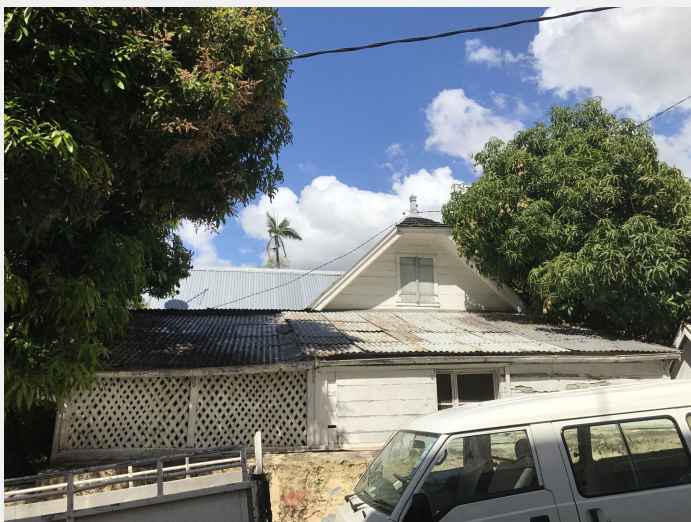
Photo 199
Remarkable housing type well preserved.
Preserved annexes

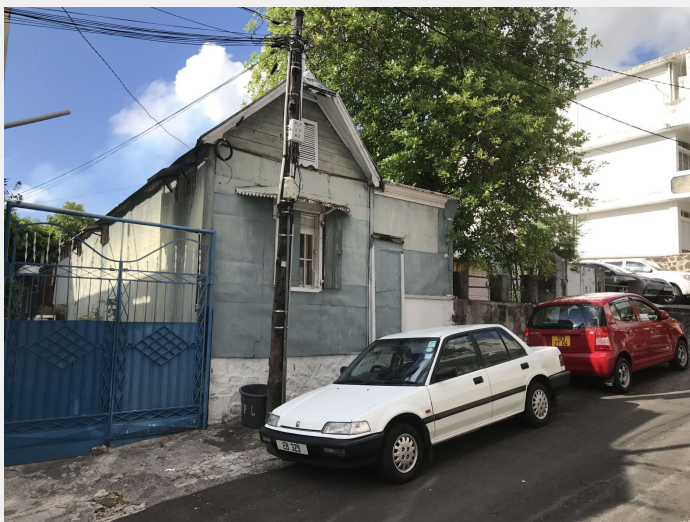
Photo 213
Still inhabited

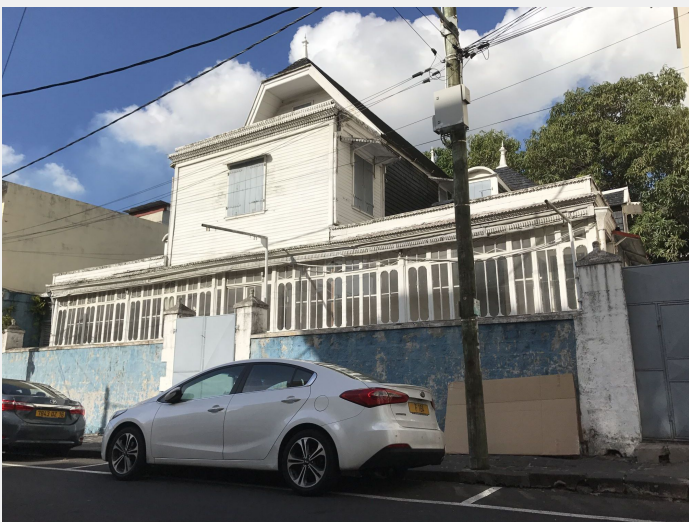
Mansard roof with dormers.
Photo 214-216

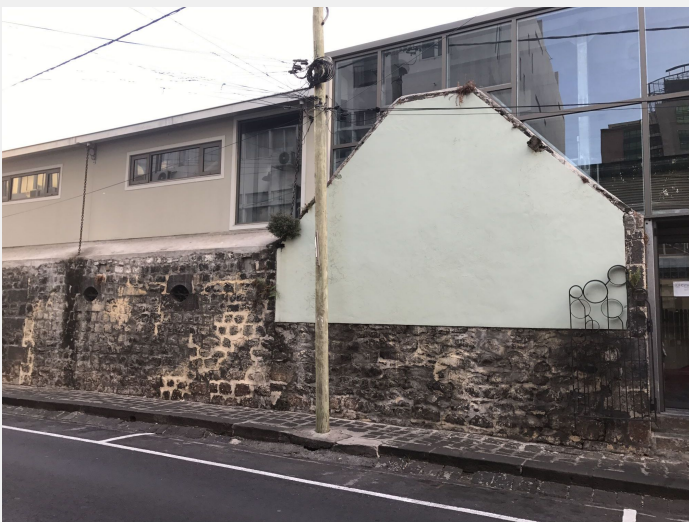
Photo 259-260
The building is visible on the the north waster side and is made by stones.

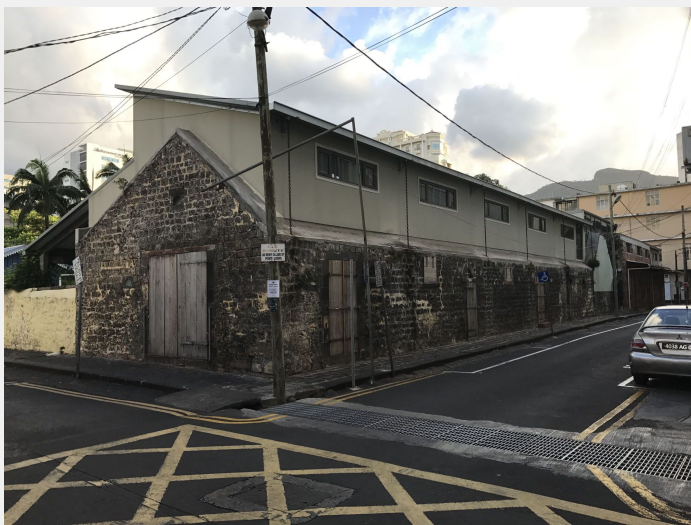
Photo 261-262

The stone warehouse with for the frames and smaller ones for the sidings located in the nord western half of block 72. The building was recently restored with a superfetation of a concrete building. It has three doors on the north waster wall.

The building was probably restored or

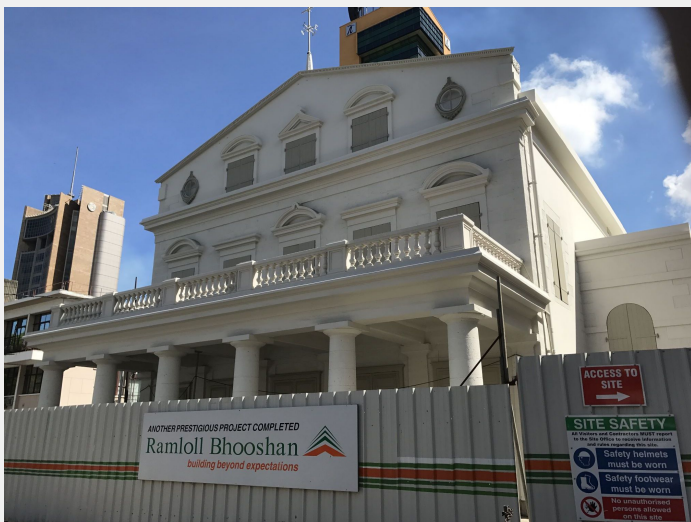
Photo 657-660

The construction of the theatre started in 1820. It was inaugurated on 1822 and is one of the oldest in the Southern Hemisphere.

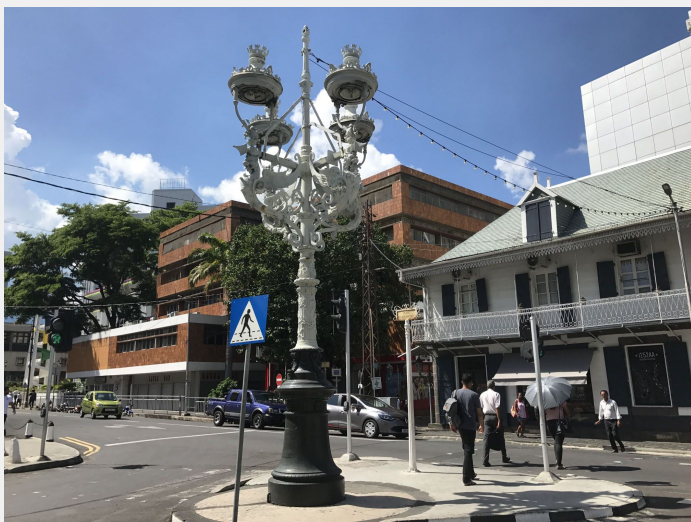
Lamppost made by iron in the middle of the place Nelson Mandela.

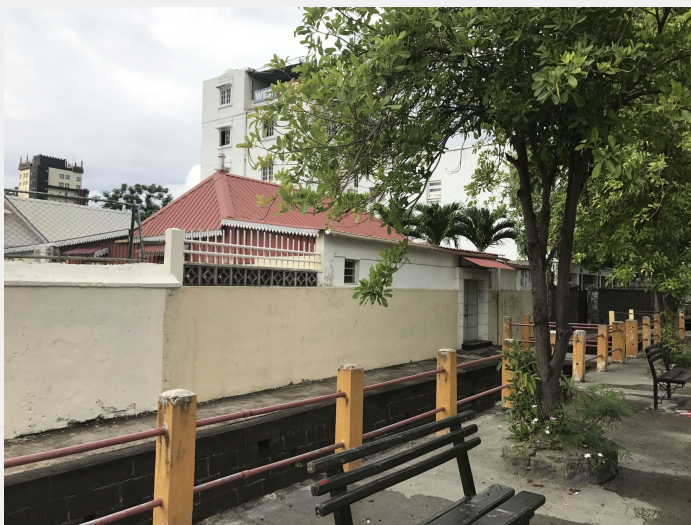
Photo 177-178

Building	Site Name	Site Code	Year / Season
148	Port Louis	PL	2019
Ward number W4	Block number 260	Elevation	Measure, Length
Building/Structure Type House	Building status Original		Types of analysis Photo
Visibility Poor	Preservation Status Adequate		
Distinction Parameters Building technique	Bdg.Type		
Neighbourhood	Address Pope Hennessy Street		Construction Materials
Openings Notes			
Roof Material	Roof Type	Roof Notes	
Siding Material	Siding Notes		
Dating Elements	Proposed chronology		
Photo, Sketch or Audio Comment			Description

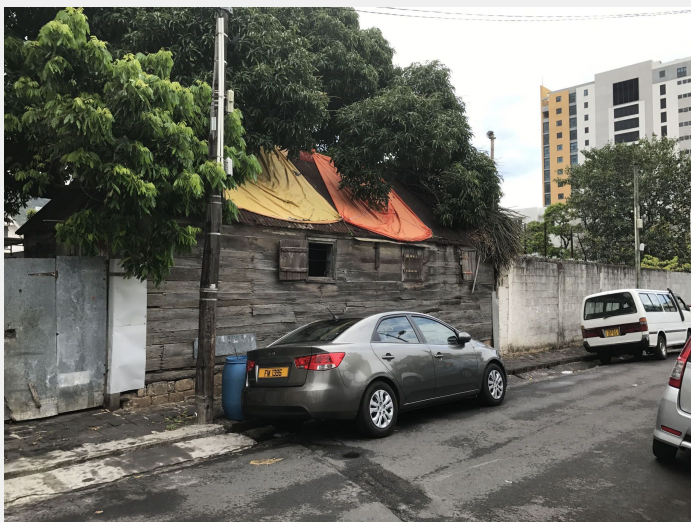
Photo 179-181

Building	Site Name	Site Code	Year / Season
149	Port Louis	PL	2019
Ward number W4	Block number 260	Elevation	Measure, Length
Building/Structure Type House	Building status Original		Types of analysis Photo
Visibility Good	Preservation Status Adequate		
Distinction Parameters Building technique	Bdg.Type		
Neighbourhood	Address Rue L'Eglise		Construction Materials
Openings Notes			
Roof Material	Roof Type	Roof Notes	
Siding Material	Siding Notes		
Dating Elements	Proposed chronology		
Photo, Sketch or Audio Comment			Description
